## **URGENT MEDICAL DEVICE CORRECTION (NOTIFICATION)**

### **Update to Instructions for Use US Customer Letter**

Impella Product Code	Impella Product Description	UDI-DI
0046-0035	Impella RP® with SmartAssist®	00813502011869
1000323	Impella RP Flex™ with SmartAssist®	00813502012811

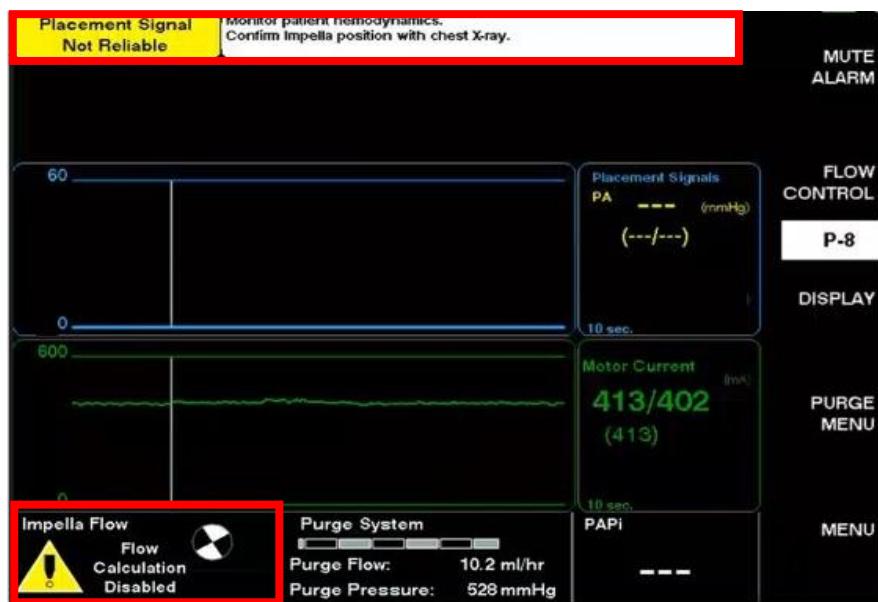
Figure 2: Example AIC screen during PSNR due to the dP sensor

Abiomed has identified a risk of dP sensor drift in Impella RP® pumps, which may cause inaccurate flow readings, Pulmonary Artery (PA) Placement Signal, Pulmonary Artery Pulsatility Index (PAPi) and Central Venous (CV) Placement Signal. There is no way to confirm error in the flow calculation directly from the pump signals in these situations. When the dP sensor signal exceeds the operating range for the sensor, the flow calculation will disable and a “Placement Signal Not Reliable” (PSNR) alarm will be displayed on the AIC, as shown in Figure 2. Please note that the PSNR alarm may not be triggered in all instances of dP sensor drift.

When the differential pressure sensor signal exceeds the operating range for the sensor, a Placement Signal Not Reliable alarm will occur, the controller will no longer calculate the PA Placement Signal, the Central Venous Placement Signal, nor the Impella flow rate, and the controller will display a yellow triangular caution icon with the message "Flow Calculation Disabled." When this occurs, refer to Table 5.4 P-Level Flow Rates, and monitor the motor current waveform and the circular catheter operation icon to monitor pump function. Continue to monitor patient hemodynamics using cleared or approved diagnostic devices and continue to monitor Impella positioning with imaging.
