## **URGENT MEDICAL DEVICE RECALL (CORRECTION)**

### **Introducer for Impella (*sold within Impella Pump Sets and Individually Packaged*)**

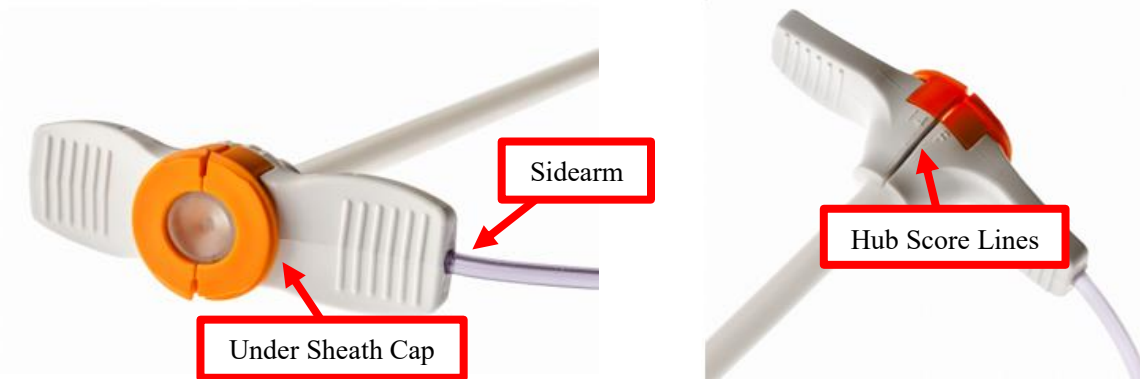
Abiomed has identified a potential for introducer sheath leakage from the sidearm and under the sheath cap and along the hub score lines in the hub region, identified in 14Fr and 23Fr Introducers. The unexpected leakage in these specified locations is due to certain manufacturing related issues, which increase the risk of access-site bleeding. Abiomed, in collaboration with its contract

If this issue were to occur, the user would see blood loss at the sidearm and hub of the introducer sheath as shown below on the 14Fr introducers. Leak locations are the same for both 14Fr and 23Fr introducers.

Areas where users may see blood loss from the sidearm and hub region:

- Product removal is not required, and hospitals may continue to use existing inventory. Physicians should continue to use appropriate clinical awareness, monitoring, and patient support as needed. Consider a device exchange or using the repositioning sheath to minimize blood loss if potential leakage from the sidearm and under the sheath cap and along the hub score lines in the hub region is observed.
