URGENT MEDICAL DEVICE CORRECTION (NOTIFICATION)

Update to Instructions for Use

| Impella Product Code | Impella Product Description | UDI-DI |
|---|--|---|
| 0046-0035 | Impella RP [®] with SmartAssist [®] | 00813502011869 |
| 1000323 | Impella RP Flex [™] with SmartAssist [®] | 00813502012811 |

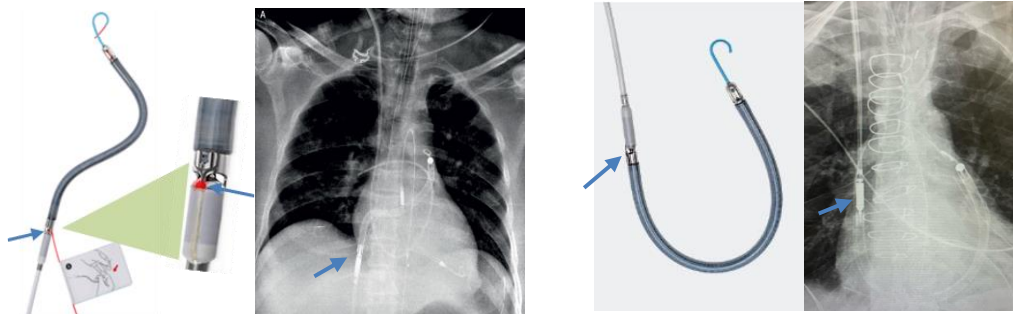
Reference for location of optical sensor in Impella devices

The optical sensor is intended as an informational tool on the Impella RP[®] with SmartAssist[®] and Impella RP Flex[™] with SmartAssist[®] pumps and is not used for any positioning algorithms/alarms or flow calculations. Optical sensor damage results in a Placement Signal Not Reliable (PSNR) alarm and loss of Central Venous Placement (CVP) Signal, Pulmonary Artery (PA) Placement Signal, and Pulmonary Artery Pulse Index (PAPi) metrics.

It is recommended that users lower the pump flow level to P-2 and use imaging guidance when inserting, manipulating, or removing any guidewires, indwelling venous lines or devices to reduce the potential for interaction of the device tip with the pump inlet.

If optical sensor damage occurs and Placement Signal Not Reliable (PSNR) alarm is displayed no additional actions are required. Hemodynamic support and Impella position are not affected and can be monitored as part of routine patient/pump management. In addition, calculated flow and suction monitoring are also unaffected when an optical sensor PSNR alarm is displayed.
