URGENT MEDICAL DEVICE CORRECTION (NOTIFICATION)
(Letter Issued on June 25, 2025 was Updated; see below)

Product Code(s)	Product Description(s)	UDI-DI(s)
0042-0000-US	Impella Controller, Packaged, US	00813502010022
0042-0010-US	Impella Optical Controller, Packaged, US	00813502010985
0042-0040-US	Optical, AIC, Impella Connect, Pkgd, US	00813502011401
1000432	AIC w/Impella Connect for ECP	00813502013030
1000201	Dbl optical, AIC Impella Connect, Phg US	00813502010442

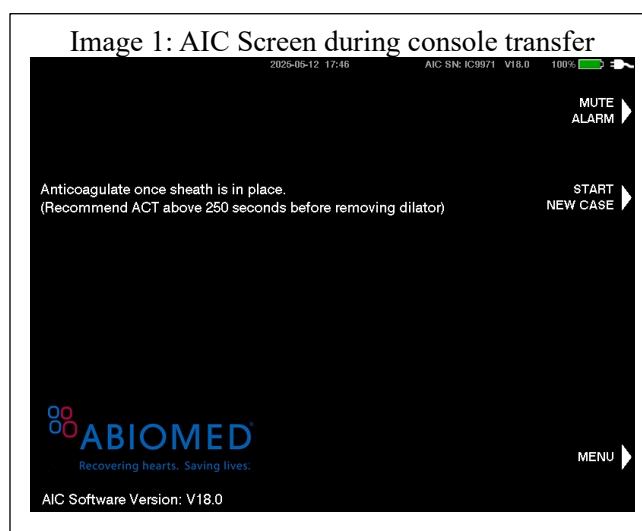
Abiomed has identified an AIC issue that may prevent the detection of an Impella pump when connected to an AIC. The pump detection issue may occur with any of the Abiomed Impella pumps and may occur during console-to-console transfer or at initiation of therapy at case start. There is no visual alarm displayed on the AIC screen to indicate the detection issue in these situations.

During console-to-console transfer, if the pump is not detected once connected to the AIC, the AIC screen in Image 1 remains and does not advance. This is the only screen that will be shown in this transfer scenario.

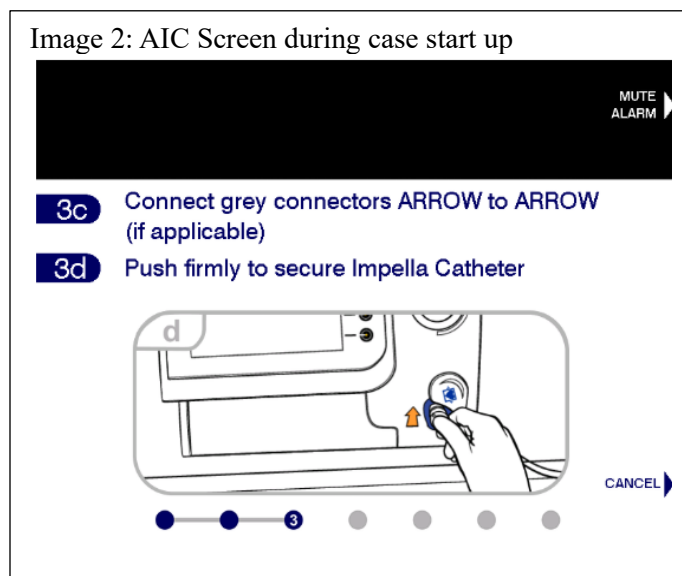
During case start, if the pump is not detected once connected to the AIC, the AIC screen in Image 2 remains and does not advance.

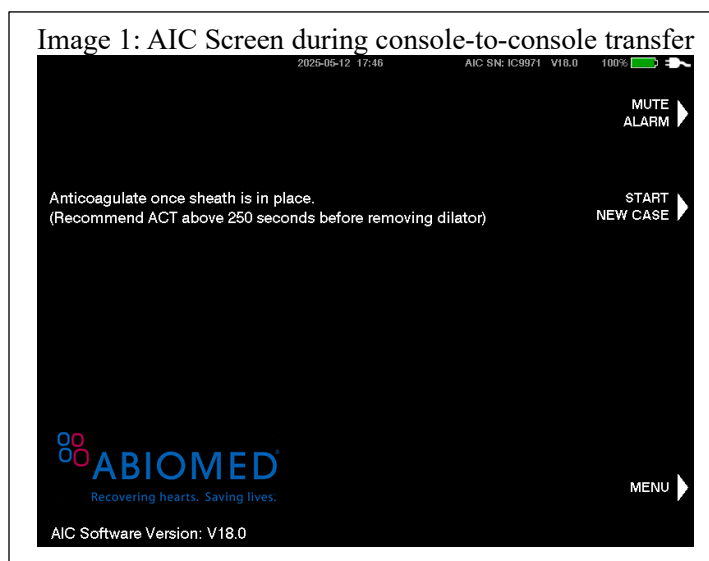
If the AIC screen in Image 1 remains for more than 20 seconds and does not advance after connecting the pump to the transferred console:

- Immediately switch the pump to the previous console to restore support to the patient.
- If the previous console displays an alarm message, switch to a different console if available.
- Restart the console that does not advance from Image 1 before attempting to re-connect a pump.

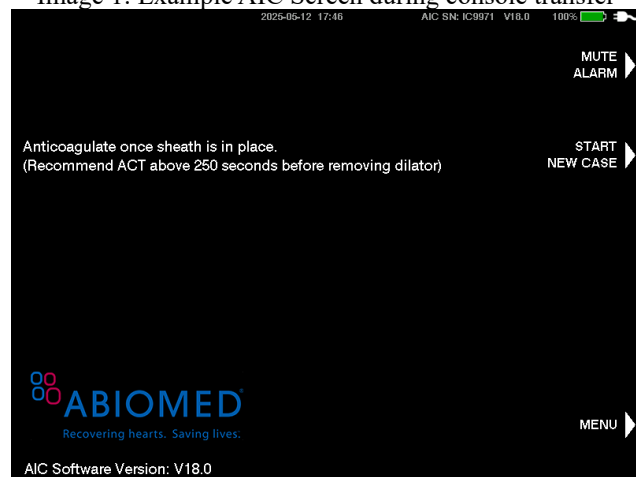
Image 1: Example AIC Screen during console transfer

During console-to-console transfer, if the AIC screen in Image 1 remains for more than 20 seconds and does not advance after connecting the pump to the transferred console:

- Immediately switch the pump to the previous console to restore support to the patient.
- If the previous console displays an alarm message, switch to a different console if available.
- Restart the console that does not advance from Image 1 before attempting to re-connect a pump.
